Sample Non-Contacting Face Seal Application: Gear Box

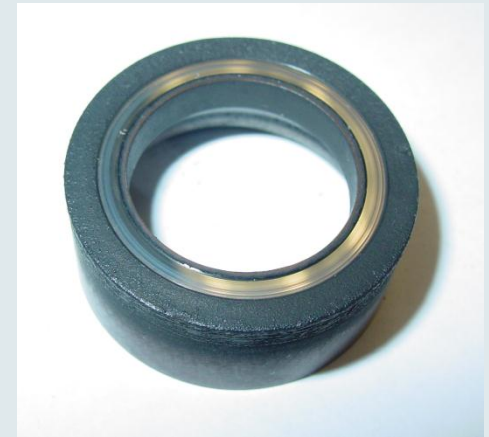
- ▶ High heat generation of seals caused oil to coke
- ▶ Abrasive coke particles became embedded in sealing faces causing excessive leakage and wear
- ▶ Seals had to be replaced on wing before scheduled maintenance of gear box due to excessive leakage

Mating Ring with Coke from High Heat Generation

- ▶ Designed a new non-contacting carbon face seal with hydrodynamic features on mating ring to reduce heat generation
- ▶ New design allows for maintenance-free seals before gear box is pulled for scheduled maintenance
- ▶ Final design solution required **NO COST INCREASE** over original product

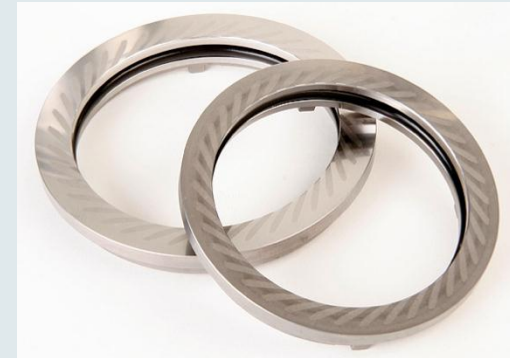
Mating Rings with Hydrodynamic Features
